GLASS BREAK

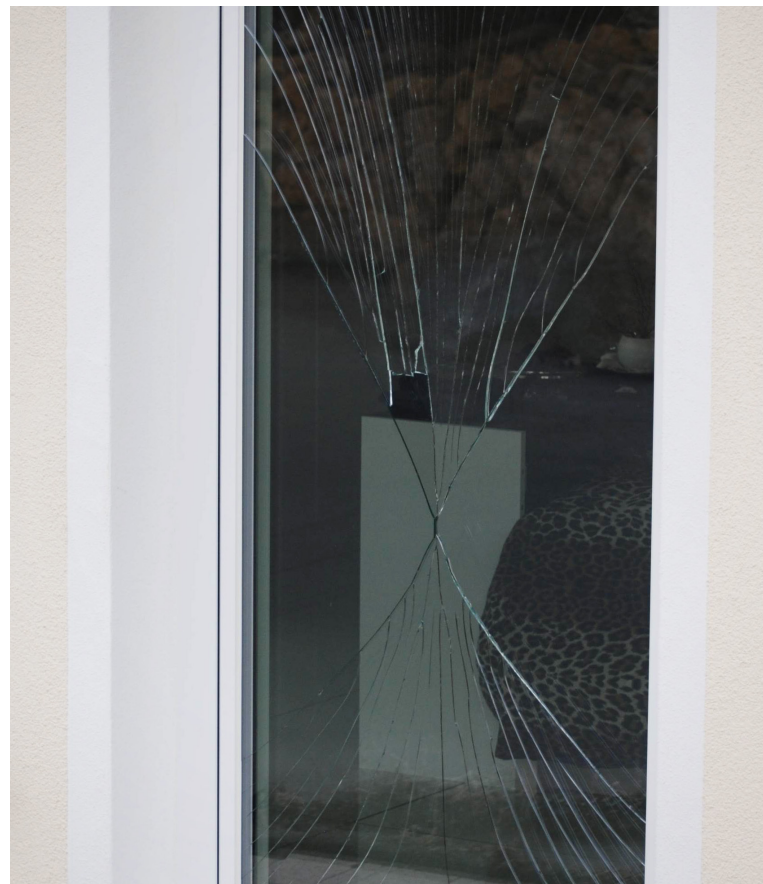
This type of glass breakage occurs when the amount of gas hermetically sealed in the space or cavity between the glass panes of the insulating glass unit expands or contracts dramatically. As the width of the space between the panes increases, this double-pane or insulating glass effect becomes more pronounced. It is most noticeable in triple insulating glass units with two very wide spaces between the panes. The decisive factors for such jumps are changes in air pressure and temperature and the difference in altitude between the production site and the installation site of the glass pane.

Inward deflection of insulating glass always occurs when the temperature drops (e.g. in winter) and at the same time the air pressure is higher than it was on the day the glass was manufactured.

In contrast, outward deflection of panes occurs at very high outdoor temperatures, at lower atmospheric pressure than at the production site, and when the insulating glass is installed in considerably higher altitude regions than the production site.

Different glass thicknesses and pane formats have an additional negative influence on this. In addition, very narrow and long formats are more likely to be affected because they are exposed to considerably more loads than large-format panes.

Pressure jumps can occur in all non-tempered glass such as float glass, laminated safety glass made of float glass or ornamental glass.

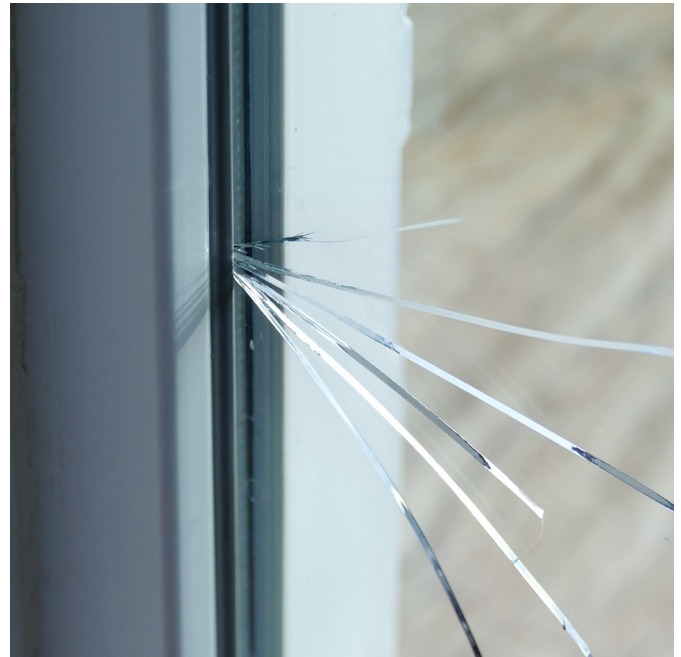
Compared to this, the assessment of purely thermally induced breakages, i.e., those caused by excessive partial heating of a pane surface, is much easier. A mere glance at the edge of the glass is sufficient for this. The edge of the glass is where one can see the typical characteristics of a thermally induced glass breakage: a crack origin that is perpendicular to the edge of the glass and runs perpendicular from the edge to the glass surface. If both these characteristics are present, it can be said with absolute certainty that this is a thermally induced glass breakage. This type of breakage can occur in float glass, laminated safety glass made of float glass as well as with ornamental glass. However, this does not occur in heat strengthened glass or tempered safety glass as these types of glass are much more resistant to changes in temperature.

The perpendicular path of the crack starting from the edge of the glass is characteristic of a breakage pattern due to thermal stress.

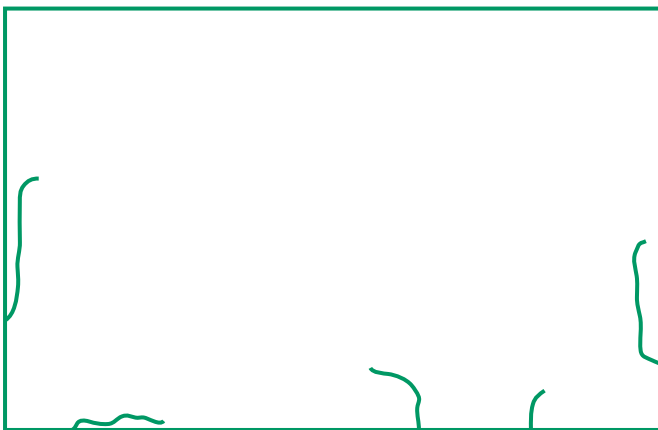
Clamping cracks occur, for example, due to incorrect use of glazing blocks or excessive clamping, when changes in the length of the glass and frame are not considered, when the glass weights are very high or when the glazing blocks are too small.

Identifying such cracks is not easy because they do not have typical fracture paths. Therefore, detailed on-site investigations of the situation need to be carried out to determine the causes of the breakages.
